The 40th JCI Technical Conference

[1253] APPLICABILITY OF BIO-BASED MATERIALS TO REPAIR WATER LEAKAGE OF CONCRETE

APPLICABILITY OF BIO-BASED MATERIALS TO REPAIR WATER LEAKAGE OF CONCRETE

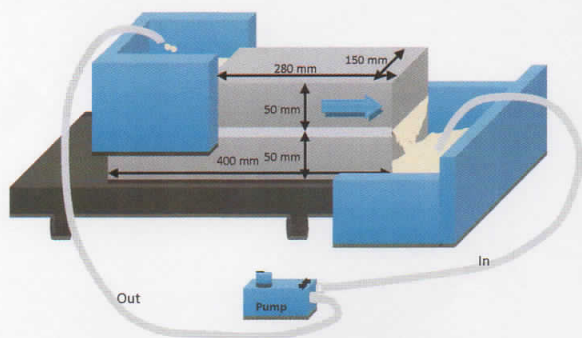
Fig. 2 Experimental set-up for bio-based repair materials and water permeability test

The concrete specimen is propped horizontally. The dimension of the specimen is 400x150x50 mm (bottom side), and 280x150x50 mm (upper side) placed parallel and made crack subsequently. These specimens were sealed with waterproof tape to prevent repair mixtures from leaking through the right and left side of specimens as shown in Fig. 2. Three type of water permeability test are shown in Table 3. Test type A is the main test. The result of water permeability test obtained from the test type A was compared with flow rate result obtained from test type B and C. The effectiveness of bio-based repair materials was evaluated based on consecutive measurements once per 24 hours for the reduction of water leakage in the concrete specimens.

crack were measured for 5 minutes. And then, selected mixtures were poured into the crack. A container is placed underneath the specimen to collect the water drained out through the leakage. The digital scale with a maximum capacity of 2000 g and resolution 0.1 gr is used to measure the weight over time of the water outflow from the leakage. It was removed prior to the water permeability tests which were finally carried out using the specimens in which cracks were supposed to be sealed with precipitated calcium carbonate. In case there is no leakage in the main body or the cracks is sealed already, the water will be no flow at all. A manual stopwatch was used to monitor this time interval.

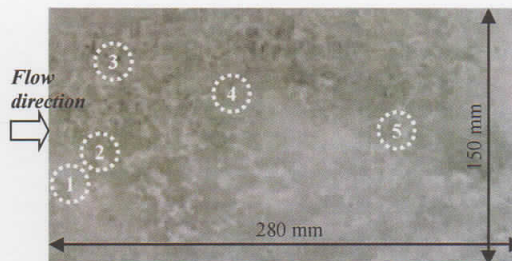
Fig. 3 Surface of concrete specimen (test type A) before pouring bio-based repair materials. Section marked with points where FT-IR observation will be spotted

The test type A was first observed under portable digital microscope to analyze and locate the expected bio-minerals deposition. It was planned the observation would be carried out in five different points throughout the surface of the specimen as sketched in Fig. 3; in the

inflow area, slightly below the inflow area, two points in the mid-section, and slightly near to the outflow area. This was intended to obtain higher likelihood to collect evidence of bio-based material activity and identify mineral characteristics.

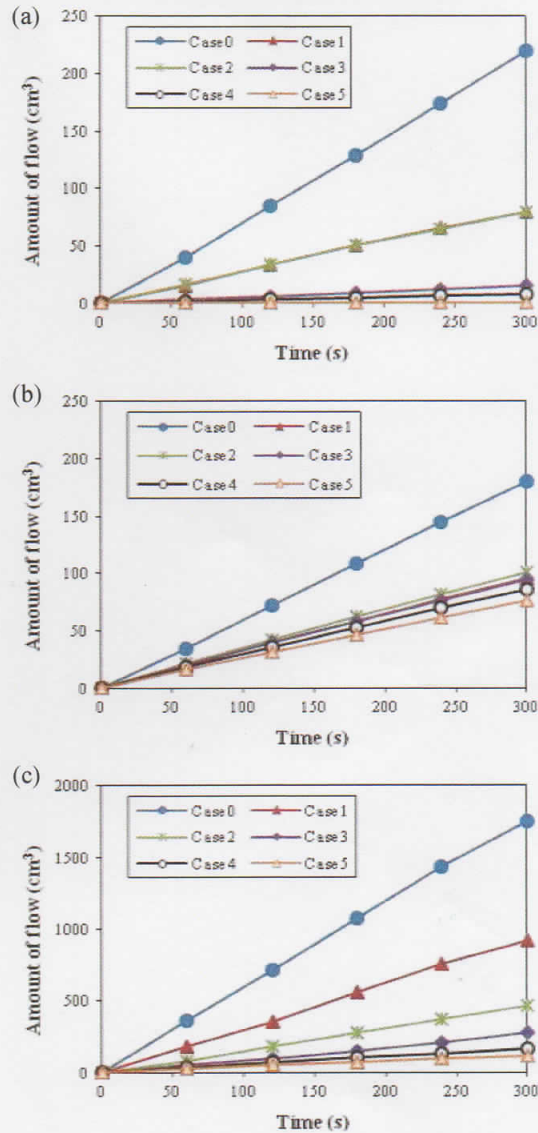
Fig. 4 Result of water permeability test for (a) test type A; (b) test type B and (c) test type C

predetermined intervals up to 300 s as shown in Fig. 4. As can be seen, the water flowing through the cracked section was substantially decreased, which was prominent in the case of mixture poured into the specimens after the mixture was left in room conditions.

Fig. 4(a) shows the result of water leakage test for test type A. Flow rate is the slope of the straight line between amount of flow (cm^3) and time (s). As can be seen, $0.73 \text{ cm}^3/\text{s}$ water flowing through the gaps before the bio-based material was poured into the cracked specimen. After the mixture poured, it was decreased to $0.26 \text{ cm}^3/\text{s}$ after 24 h and to $0.03 \text{ cm}^3/\text{s}$ after 72 h. The flow rate is zero after 96 h. In this time, post-repairing permeability test revealed a zero slope which can be interpreted there was no water flow out from the crack.

This result compares to the water leakage test on test type B and C as shown in Fig. 4(b) and (c). On the other hand, for test type B, there was no significant difference of water leakage from 24 h up to 96 h. It was clear that no precipitation of calcium carbonate after 96 h because the mixture has not contained calcium acetate. Decreasing of water leakage caused by sedimentation of yeast and glucose on the surface of the cracks. This result confirmed by visual observation.

For test type C, the leakage with crack width 0.6 mm was too large to close on 96 h elapsed time. Until 96 h after pouring the mixture, the flow rate in the specimen about $0.38 \text{ cm}^3/\text{s}$. In this case, the test continue until water leakage decreasing to zero. The flow rate is zero after 9-days (216 h) pouring of the bio-based materials.

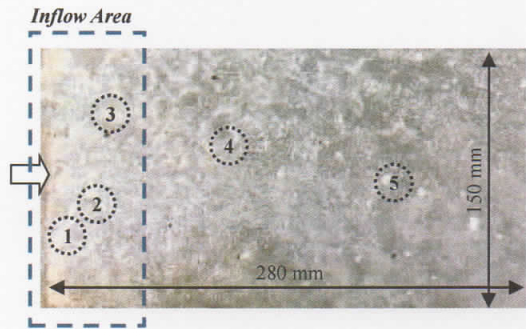
Fig. 5 Surface of concrete specimen after 96 hours pouring of bio-based materials (test type A)

Fig. 5 displays the surface of concrete specimens after the water permeability test were carried out. Formation of suspected newly Ca-based materials is visually seen by comparing to Fig. 3. Mostly, the

calcium carbonate precipitated in the inflow area of the specimen. The widespread precipitates in the specimens led to the significant decrease in the water permeability. Furthermore, the results suggested that precipitated calcium carbonate in cracked part concomitant with seeping into deeper zones of concrete specimens was crucial to decrease water leakage effectively.

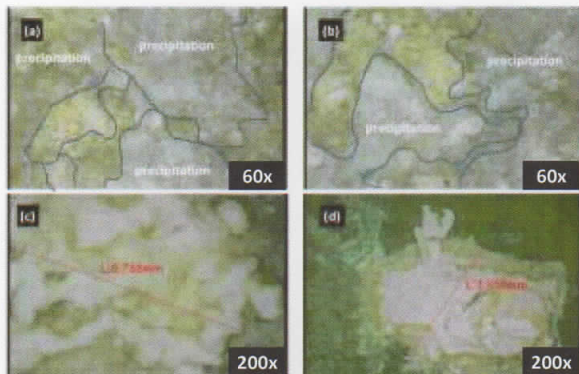
Fig. 6 Images of the post-repairing specimen were taken by 3R Anyty microscope showing the newly formed materials suspected as Ca-based minerals (test type A).

Precipitation comprising calcium carbonate was visually confirmed in the area surrounding the cracked surface after 4-day pouring of the mixture, some of which was observed using a portable digital microscope as shown in Fig. 6. Fig. 6a and b were after 60x magnifications, and Fig. 6c and d were for 200x magnifications. It is worth noting that the precipitated calcium carbonate would be present in the cracked parts even the bio-based materials mixture is flowing through the cracks. Following the visual observation, the image analysis was carried out for the FT-IR and FE-SEM test.

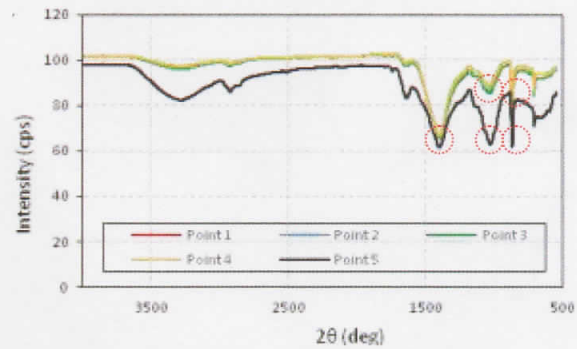
Fig. 7 Spectra of FTIR Analysis in five different points

Fig. 7 and 8 present the images of FT-IR and FE-SEM observation. The images were taken from the precipitation on the surface of the test type A. Observation revealed Ca-based surface layer which may be attributed due to carbonation.

The FT-IR analysis confirms the chemical element of calcium carbonate in the crystal which is essentially associated with calcium carbonate precipitated mediated by bio-based repair materials. The IR Spectra were recorded using Thermo Scientific Nicolet iS5 Spectrometer and stores using spectroscopic software (Omnic software)[14]. Fig. 7 is the spectra of FT-IR analysis on precipitate scrapped from the specimen after 4 days. At point 1, the peaks at 1392.35, 1031.73 and 871.667 indicated the presence of calcium carbonate. For precipitation at point 2 and 3, the signals at 1403.924, 1033.658 and 871.67 show the presence of calcium carbonate respectively. Correspondingly, a similar tendency was observed as shown in spectra at point 4. It shows peaks 1392.35, 1031.73 and 871.667. Moreover, precipitation at point 5 also indicates the presence of CaCO_3 , the peaks at 1394.281, 1029.801 and 871.67. These spectra were compared to the standard spectrum of calcium carbonate from NIST Standard Reference Database[16]. As a result, this spectrum shows that the precipitate is composed in majority of calcium carbonate. This result combined with the FE-SEM observation strongly indicates that bio-based involve at 4 days. This result

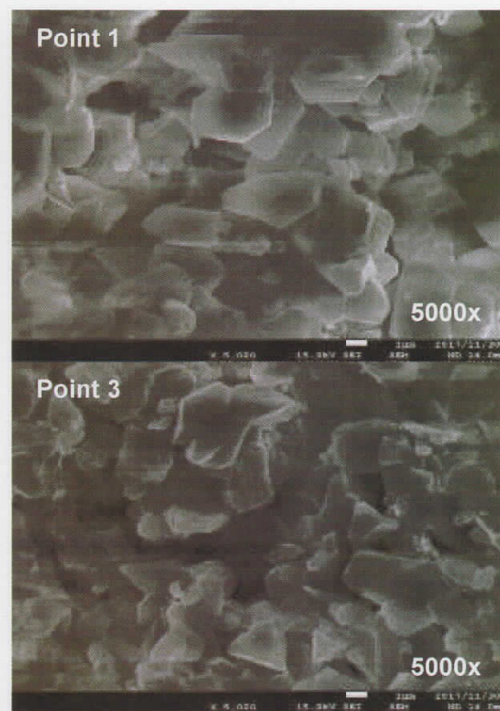
Fig. 8 FE-SEM Analysis of precipitation in point 1 and 3 (5000x magnification)

A Field Emission Scanning Electron Microscope (FE-SEM, JEOL JSM-7001FA) element were employed to analyze in depth the surface feature of the polished section. Fig. 5 exhibits the FE-SEM image taken at point 1 and 3 from the specimen. The JSM-7001F is a versatile high-performance FE SEM. The electron produces the maximum 200nA probe current with the patented in-lens thermal FEG and small probe diameter even at the large probe current with the patented aperture angle optimizing lens[15].

In the event of calcium acetate was used as the calcium source, rhombohedral carbonate crystals were obtained as shown in Fig. 8. Scanning electron microscopy of rhombohedral CaCO_3 crystals on the surface of mortar specimens treated with bio-based materials and a nutrient of glucose and calcium acetate.
